NRL Report 8258

Fractographic Analysis of Fatigue Specimens of Annealed Type 304 Stainless Steel

V. PROVENZANO AND F. A. SMIDT, JR.

September 21, 1978

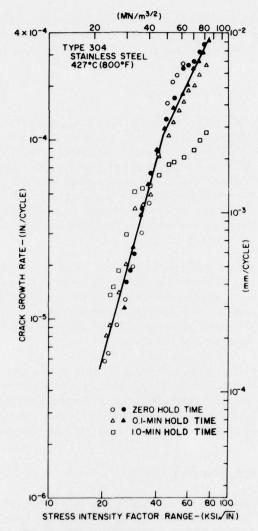
Fig. 1 — Effect of hold time on fatigue crack propagation rate, da/dN, in air at 427°C for solution-annealed Type 304 stainless steel, Heat B.

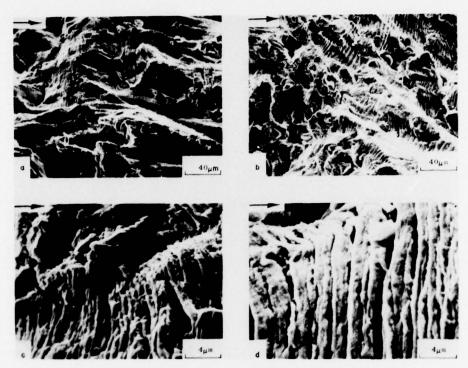
Typical SEM micrographs of the SA material, Heat B, tested at 427° C without hold time are shown in Fig. 2. The fracture surface shows a transgranular mode of failure for all values of Δ K. Fatigue striations are clearly visible in all four micrographs. These striation markings are typical of those found in ductile metals (7) as a consequence of the alternate extension of the crack by shear and the subsequent compression of the crack tip region during the unloading part of the cycle.

Fig. 2 — Fracture surfaces of a solution-annealed stainless steel specimen, Heat B, tested at $427^{\circ}\mathrm{C}$ with zero hold time. Arrows show direction of macroscopic crack propagation. The SEM micrographs were taken at crack lengths that correspond to the following ΔK values: (a) $22~\mathrm{MPa}\sqrt{m}$ (20 ksi $\sqrt{\mathrm{in.}}$), (b) $44~\mathrm{MPa}\sqrt{m}$ (40 ksi $\sqrt{\mathrm{in.}}$), (c) $22~\mathrm{MPa}\sqrt{m}$ (20 ksi $\sqrt{\mathrm{in.}}$), and (d) $27.5~\mathrm{MPa}\sqrt{m}$ (25 ksi $\sqrt{\mathrm{in.}}$). Transgranular features with fatigue striations are clearly visible in all four micrographs.

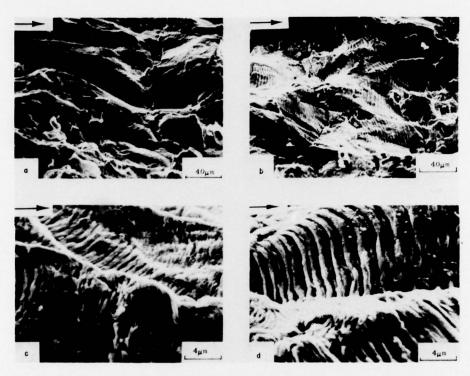
Measurements of the striation spacing at both high and low ΔK show a close correlation with the calculated da/dN values. The striation spacing increases as higher growth rates per cycle and higher ΔK values are noted. This is illustrated by two high-magnification micrographs (Fig. 2, c and d). Imposition of a hold time up to 1 min produced no noticeable change in the appearance of the fracture surface, as can be seen in Fig. 3.

Fig. 3 — Fracture surfaces of a solution-annealed stainless steel specimen, Heat B, tested at 427°C with 1-min hold time. Arrows show direction of macroscopic crack propagation. The SEM micrographs were taken at crack lengths that correspond to the following Δ K values: (a) 22 MPa \sqrt{m} (20 ksi $\sqrt{\text{in.}}$), (b) 44 MPa \sqrt{m} (40 ksi $\sqrt{\text{in.}}$), (c) 22 MPa \sqrt{m} (20 ksi $\sqrt{\text{in.}}$), and (d) 33 MPa \sqrt{m} (30 ksi $\sqrt{\text{in.}}$). Similar to the micrographs shown in Fig. 2, the failure mode is transgranular with distinct fatigue striations whose average spacing increases with Δ K.

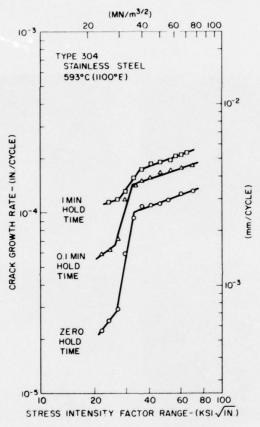
Crack growth rate data for 0, 0.1-, and 1-min hold times (2) are presented in Fig. 4. The crack growth rate for the specimen tested with no hold time increased from approximately 4.5×10^{-3} mm/cycle (2.3×10^{-4} in./cycle) at 22 MPa \sqrt{m} (20 ksi \sqrt{m} .) to 3.5×10^{-3} mm/cycle (1.3×10^{-3} in./cycle) at 88 MPa \sqrt{m} (80 ksi \sqrt{m} .). This crack growth rate is more than one order of magnitude higher than the growth rate of the same material tested at 427° C for comparable values of Δ K. The crack growth rate curves exhibits a small change in slope at 33 MPa \sqrt{m} (30 ksi \sqrt{m} .) and another larger change in slope at 44 MPa \sqrt{m} (40 ksi \sqrt{m} .). Introduction of 0.1- and 1.0-min hold times during the fatigue cycle increased the crack growth rate as compared to the test with no hold time. Similar to the zero-hold-time test, the two crack growth rate curves exhibit two changes in the slope at approximately the same values of Δ K. Since these changes in the slope occur in the region of Δ K where the mechanical data are most reliable, they cannot be easily discounted. This point will be taken up again in the discussion section of this report.

Fig. 4 — Effect of hold time on fatigue crack propagation rate, da/dN, in air at 593° for solution-annealed Type 304 stainless steel, Heat B.

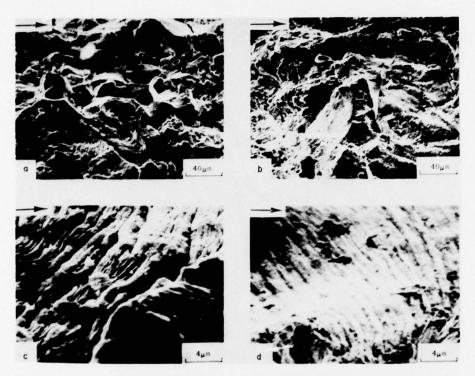
Typical SEM micrographs of the SA specimen tested at 593° C with no hold time are shown in Fig. 5. As in prior figures, these micrographs include representatives from both low- and high- Δ K regions of the test. At crack lengths up to 10 mm (0.4 in.) (which corresponds to a Δ K value of 33 MPa \sqrt{m} .(30 ksi \sqrt{in} .)), the failure mode was mixed, as can be seen in Fig. 5, a and b. Some areas exhibit intergranular failure while others quite obviously show the characteristics of the transgranular failure mode. At Δ K levels above 33 MPa $\sqrt{(30 \text{ ksi}\sqrt{in}.)}$, the failure mode changed to 100% transgranular and fatigue striations are clearly visible (Fig. 5, c and d). The striation spacing correlates well with da/dN values calculated from the crack extension data. Behavior of this type was also noted in the previous study on Type 316 (1). The introduction of a 1-min hold time during the fatigue cycle increased the percentage of area characterized by intergranular failure and increased the Δ K level at which transgranular failure occurred, as can be seen in Fig. 6.

Fig. 5 — Fracture surfaces of a solution-annealed specimen, Heat B, tested at 593° C without hold time. The SEM micrographs were taken at crack lengths that correspond to the following Δ K values: (a) $22 \text{ MPa} \sqrt{m}$ ($20 \text{ ksi} \sqrt{\text{in.}}$), (b) $27.5 \text{ MPa} \sqrt{m}$ ($25 \text{ ksi} \sqrt{\text{in.}}$), (c) $33 \text{ MPa} \sqrt{m}$ ($30 \text{ ksi} \sqrt{\text{in.}}$), and (d) $44 \text{ MPa} \sqrt{m}$ ($40 \text{ ksi} \sqrt{\text{in.}}$). Arrows show direction of macroscopic crack propagation. The fracture mode is mixed — intergranular and transgranular — in the low- Δ K region and totally transgranular in the high- Δ K region.

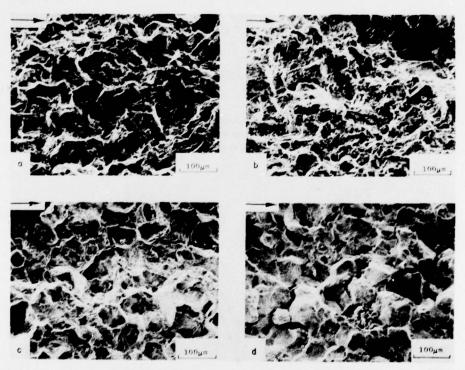
Fig. 6 — Fracture surfaces of solution-annealed Type 304 stainless steel specimens, Heat B, tested at 593° C with 0.1-min hold time ((a) and (b)) and 1-min hold time ((c) and (d)). The SEM micrographs were taken at crack lengths that correspond to the following ΔK values: (a) $22 \text{ MPa}\sqrt{m}$ (20 ksi $\sqrt{\text{in.}}$), (b) $33 \text{ MPa}\sqrt{m}$ (30 ksi $\sqrt{\text{in.}}$), (c) $22 \text{ MPa}\sqrt{m}$ (20 ksi $\sqrt{\text{in.}}$), and (d) $27.5 \text{ MPa}\sqrt{m}$ (25 ksi $\sqrt{\text{in.}}$). Arrows show direction of macroscopic crack propagation. The micrographs show that the failure mode is mostly intergranular in both fracture surfaces.

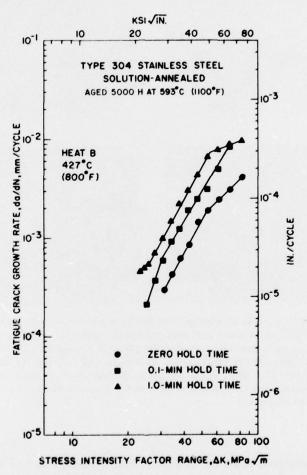
Fig. 7 shows fatigue data for aged, solution-annealed, Heat B material tested at 427° C. Except for a slight change in the slope at the upper ends of the curves, the data are linear on a log-log plot. This crack growth rate and the slope of the log da/dN vs log ΔK curve show that the zero-hold-time data are approximately the same as the corresponding values for the SA material tested at the same temperature (refer to Fig. 1). The introduction of 0.1- and 1.0-min hold time during the fatigue cycle progressively increased the growth rate. This effect of hold time in aged Type 304 stainless steel tested at 427° C differs from the observations on aged Type 316 steel tested at the same temperature where no hold time effect was observed (1).

Fig. 7 — Effect of hold time on fatigue crack propagation behavior in air at 427°C for solution-annealed, aged Type 304 stainless steel, Heat B.

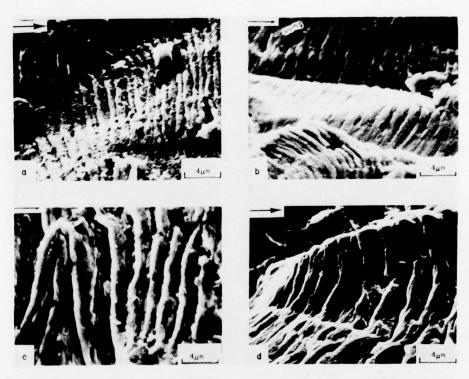
Typical SEM micrographs of aged, Heat B material tested at 427°C with no hold time are shown in Fig. 8. The micrographs reveal a transgranular failure mode characterized

Fig. 8 — Fracture surfaces of a solution-annealed, aged Type 304 stainless steel specimen, Heat B, tested at 427°C without hold time. The SEM micrographs were taken at crack lengths that correspond to the following ΔK values: (a) $22 \text{ MPa} \sqrt{m}$ (20 ksi $\sqrt{\text{in.}}$), (b) $33 \text{ MPa} \sqrt{m}$ (30 ksi $\sqrt{\text{in.}}$), (c) $44 \text{ MPa} \sqrt{m}$ (40 ksi $\sqrt{\text{in.}}$), and (d) $33 \text{ MPa} \sqrt{m}$ (30 ksi $\sqrt{\text{in.}}$). Arrows show direction of macroscopic crack growth rate. The micrographs show that the specimen failed transgranularly for all values of ΔK .

by fatigue striations whose average spacing increases with ΔK . Rather surprisingly, the specimens with hold times of 0.1 min and 1.0 min exhibited the same basic fractographic features as the specimen with no hold period. The micrographs in Fig. 9 show that the fracture mode for both 0.1- and 1.0-min hold-time tests were transgranular with clear striation markings.

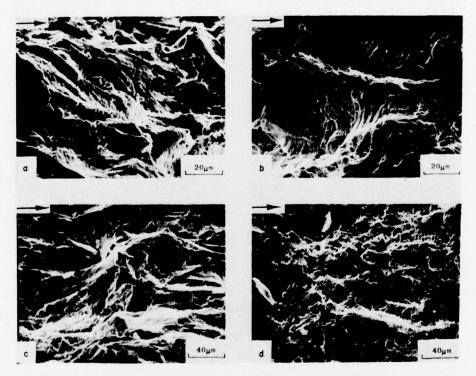
Fig. 9 — Fracture surfaces of solution-annealed and aged Type 304 stainless steel specimens, Heat B, tested at 427°C. Micrographs (a) and (b) refer to the specimen with 0.1-min hold time, while (c) and (d) refer to the specimen with 1-min hold time. The SEM micrographs were taken at crack lengths corresponding to the following ΔK values: (a) $22 \text{ MPa}\sqrt{m} (20 \text{ ksi}\sqrt{\text{in.}})$, (b) $33 \text{ MPa}\sqrt{m} (30 \text{ ksi}\sqrt{\text{in.}})$, (c) $22 \text{ MPa}\sqrt{m} (20 \text{ ksi}\sqrt{\text{in.}})$, and (d) $33 \text{ MPa}\sqrt{m} (30 \text{ ksi}\sqrt{\text{in.}})$. Arrows show direction of macroscopic crack propagation. The micrographs show that both specimens fail transgranularly; fatigue striations whose average spacing increases with ΔK are visible in all micrographs.

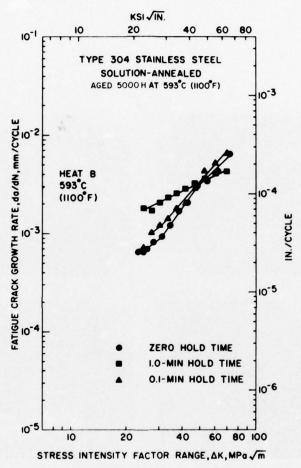
The macroscopic growth rates of aged, solution-annealed, Heat B material tested at 593° C are shown in Fig. 10. The growth rate for the specimen tested without hold time went from 5×10^{-3} mm/cycle (2×10^{-5} in./cycle) at 22 MPa \sqrt{m} (20 ksi $\sqrt{in.}$) to 1.3 \times 10⁻² mm/cycle (3×10^{-4} in./cycle) at 77 MPa \sqrt{m} (70 ksi $\sqrt{in.}$). In general, the above growth rate is slightly faster than the growth rate found at 427°C for the same aging treatment (refer to Fig. 5). Imposition of a 0.1-min hold time produced a faster growth rate

Fig. 10 — The effect of hold time on fatigue propagation rates, da/dN, in air at 593°C for solution-annealed, aged Type 304 stainless steel, Heat B.

in the ΔK region below about 49.5 MPa \sqrt{m} (45 ksi \sqrt{in} .) and a slower growth rate above 49.5 MPa \sqrt{m} , i.e., a lower slope. Rather surprisingly, the 1.0-min hold-time test had less increase in growth rate at low ΔK than the 0.1-min hold time, and nearly paralleled the zero-hold-time curve above 40 MPa \sqrt{m} (36.4 ksi \sqrt{in} .).

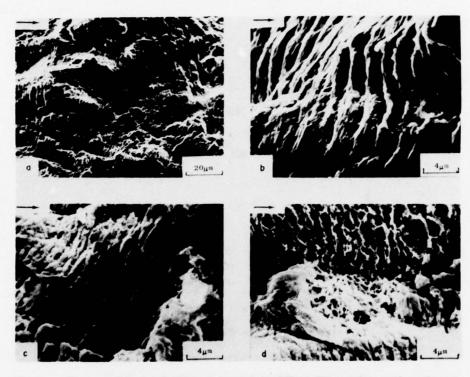
Examination of the fracture surfaces of the aged material, Heat B, tested at 593° C shows that the failure mode of the zero hold-time (Fig. 11, a and b) and 0.1-min hold-time (Fig. 11, c and d) specimens was basically transgranular with striation markings observed for all ranges of ΔK . Prominent regions where void coalescence had occurred were present in the 0.1-min hold-time specimens (Fig. 11, d). The specimen with 1-min hold time (Fig. 12) showed patches of intergranular failure in the low- ΔK region (Fig. 12, a and b), but in the higher ΔK region (Fig. 12, c and d) the mode of failure was exclusively transgranular.

Fig. 11 — Fracture surfaces of solution-annealed, aged Type 304 stainless steel specimens, Heat B, tested at 593°C. Micrographs (a) and (b) of specimen tested with no hold time, (c) and (d) of specimen tested with 0.1-min hold time. The SEM micrographs were taken at crack lengths that correspond to the following values of ΔK : (a) 27.5 MPa \sqrt{m} (25 ksi $\sqrt{\text{in.}}$), (b) 44 MPa \sqrt{m} (40 ksi $\sqrt{\text{in.}}$), (c) 22 MPa \sqrt{m} (20 ksi $\sqrt{\text{in.}}$), and (d) 27.5 MPa \sqrt{m} (25 ksi $\sqrt{\text{in.}}$). Arrows show direction of macroscopic crack propagation. The micrographs show that the two specimens fail transgranularly, partially by microvoid coalesence.

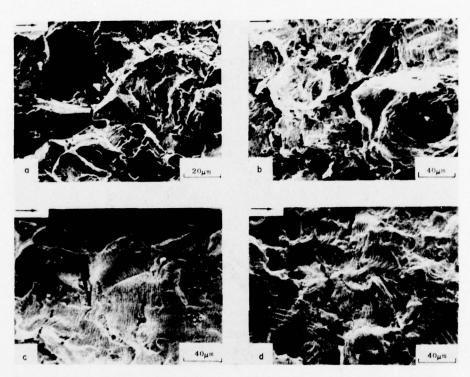
Fig. 12 — Fracture surfaces of a solution-annealed, aged Type 304 stainless steel specimen, Heat B, tested at 593° C with 1-min hold time. The SEM micrographs were taken at crack lengths that correspond to the following Δ K values: (a) 22 MPa \sqrt{m} (20 ksi $\sqrt{\text{in.}}$), (b) 27.5 MPa \sqrt{m} (25 ksi $\sqrt{\text{in.}}$), (c) 33 MPa \sqrt{m} (30 ksi $\sqrt{\text{in.}}$), and (d) 44 MPa \sqrt{m} (40 ksi $\sqrt{\text{in.}}$). Arrows show direction of macroscopic crack propagation. The micrographs show that the failure mode was mixed — intergranular and transgranular — in the low- Δ K region and completely transgranular with clear fatigue striations in the high- Δ K region.

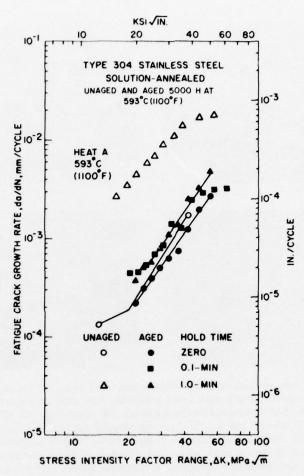
Crack growth rate data for SA material from Heat A, tested at 593° C, are shown in Fig. 13. The crack growth rate for the test with no hold time increased from 1×10^{-4} mm/cycle (4 × 10^{-6} in./cycle) at 14.3 MPa \sqrt{m} (13 ksi \sqrt{in} .) to 2.4×10^{-3} mm/cycle (6 × 10^{-5} in./cycle) at 40 MPa \sqrt{m} (36.4 ksi \sqrt{in} .). The crack growth rate is nearly linear over the above range. The introduction of 1-min hold time during the fatigue cycle increased the crack growth rate by about an order of magnitude as compared to the test with no hold time.

Fig. 13 — Effect of hold time on fatigue propagation rate, da/dN, in air at 593°C for solution-annealed, and solution-annealed and aged, Heat A material.

The fatigue data for the aged material, Heat A, tested at 593°C are also presented in Fig. 13. The data are linear in the log-log plot and approximately equal to the crack growth rate of the SA specimen of the same heat tested without hold time. Hold times up to 1 min produced a slight increase in the growth rate. Thus, the hold-time effect, clearly present in the fatigue data of the SA material, became negligibly small or was completely absent in the aged material from Heat A.

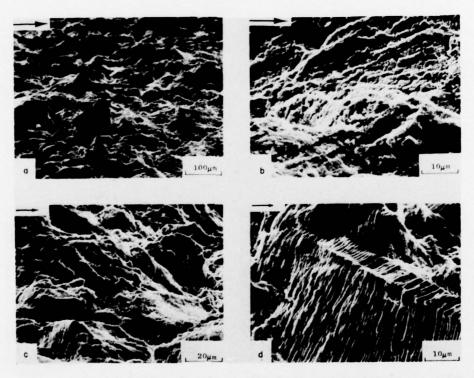
Typical SEM micrographs of the SA specimen, Heat A, tested with no hold time, are shown in Fig. 14. As illustrated in the low magnification micrograph taken in the low- ΔK region (Fig. 14, a), the fracture surface showed a mixed mode of failure: transgranular and intergranular. The high magnification micrographs, representative of the

higher ΔK regime of the test (Fig. 14, b-d) show a transgranular failure mode with fatigue striations. The imposition of a 1-min hold time caused the material to fail by a predominantly intergranular mode for all values of ΔK , as illustrated in Fig. 15. Thus the effect of the hold time is readily apparent in both the increase in growth rate and in the transition to intergranular failure.

Fig. 14 — Fracture surfaces of a solution-annealed Type 304 stainless steel specimen, Heat A, tested at 593°C without hold time. The SEM micrographs were taken at crack lengths that correspond to the following ΔK values: (a) $22 \text{ MPa} \sqrt{m}$ (20 ksi $\sqrt{\text{in.}}$), (b) 27.5 MPa \sqrt{m} (25 ksi $\sqrt{\text{in.}}$), (c) 33 MPa \sqrt{m} (30 ksi $\sqrt{\text{in.}}$), and (d) 44 MPa \sqrt{m} (40 ksi $\sqrt{\text{in.}}$). Arrows show direction of macroscopic crack propagation. The mode of fracture is transgranular except for the lowest ΔK region where the fracture mode appears to be mixed — mostly transgranular with intergranular patches.

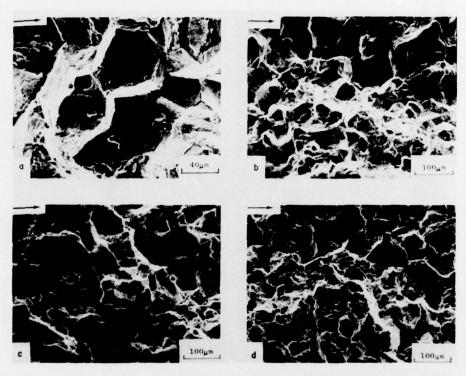
Fig. 15 — Fracture surfaces of a solution-annealed Type 304 stainless steel specimen, Heat A, tested at 593°C with 1-min hold time. The SEM micrographs were taken at crack lengths that correspond to the following ΔK values: (a) 22 MPa \sqrt{m} (20 ksi $\sqrt{\text{in.}}$), (b) 27.5 MPa \sqrt{m} (25 ksi $\sqrt{\text{in.}}$), (c) 33 MPa \sqrt{m} (30 ksi $\sqrt{\text{in.}}$), and (d) 44 MPa \sqrt{m} (40 ksi $\sqrt{\text{in.}}$). Arrows show direction of macroscopic crack propagation. As can be seen from the four panels, the specimen failed intergranularly for all values of ΔK .

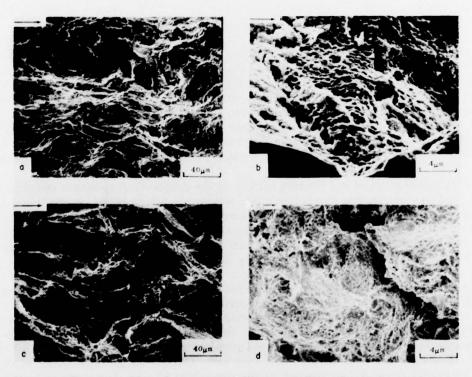
Fig. 16 — Fracture surfaces of a solution-annealed, aged Type 304 stainless steel specimen, Heat A, tested at 593°C without hold time. The SEM micrographs were taken at crack lengths that correspond to the following ΔK values: (a) $22 \text{ MPa}\sqrt{m}$ ($20 \text{ ksi}\sqrt{\text{in.}}$), (b) $27.5 \text{ MPa}\sqrt{m}$ ($25 \text{ ksi}\sqrt{\text{in.}}$), (c) $33 \text{ MPa}\sqrt{m}$ ($30 \text{ ksi}\sqrt{\text{in.}}$), and (d) $44 \text{ MPa}\sqrt{m}$ ($40 \text{ ksi}\sqrt{\text{in.}}$). Arrows show direction of macroscopic crack propagation. The specimen failed transgranularly mostly through microvoid coalescence for all values of ΔK .

Typical SEM micrographs of the aged specimen, Heat A, tested at 593° C with no hold time are shown in Fig. 16. The failure mode was transgranular for all values of Δ K. Especially in the higher Δ K region, the fracture surface was characterized by the presence of secondary cracking and shear dimples (Fig. 16, c and d). Imposition of hold times up to 1 min did not appreciably change the microstructure appearance (Fig. 17).

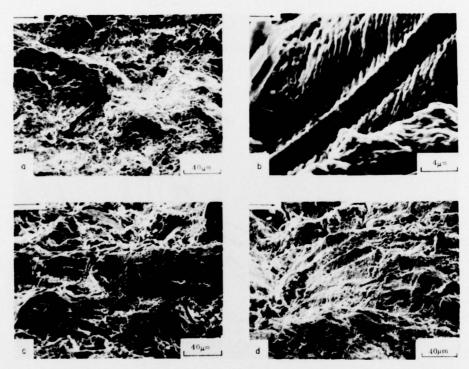
Fig. 17 — Fracture surfaces of solution-annealed, aged Type 304 stainless steel specimens, Heat A, tested at 593° C with 0.1-min ((a) and (b)) and 1.0-min ((c) and (d)) hold times. The SEM micrographs were taken at crack lengths that correspond to the following Δ K values: (a) $22 \text{ MPa}\sqrt{m}$ ($20 \text{ ksi}\sqrt{\text{in.}}$) (b) $27.5 \text{ MPa}\sqrt{m}$ ($25 \text{ ksi}\sqrt{\text{in.}}$), (c) $22 \text{ MPa}\sqrt{m}$ ($20 \text{ ksi}\sqrt{\text{in.}}$), and (d) $27.5 \text{ MPa}\sqrt{m}$ ($25 \text{ ksi}\sqrt{\text{in.}}$). Arrows show direction of macroscopic crack propagation. The failure mode was transgranular for both specimens for all values of Δ K. Microvoids can be seen where the oxide layer has been removed, while the topography of fatigue striations is visible where an oxide layer still covers the fracture surface.

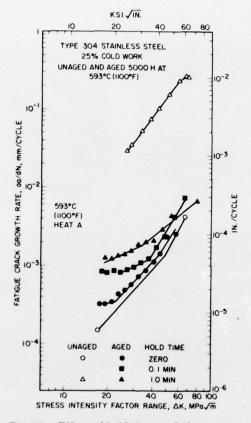
The fatigue data for the 25% cold-worked material, Heat A, tested at 593° C, are shown in Fig. 18. The data are nearly linear in the log-log plot except for a slight change in the slope at 46 MPa \sqrt{m} (41.8 ksi $\sqrt{\text{in.}}$). Imposition of a 1-min hold time during the fatigue cycle resulted in an increase in the crack growth rate by approximately 1-2 orders of magnitude compared to the specimen tested without hold time. The above crack growth rate values of the cold-worked specimen tested with 1-min hold time were about one order of magnitude higher than the corresponding values for the crack growth rate of the SA specimen, Heat A, tested at the same temperature, 593° C, with the same hold-time period.

The fatigue crack propagation data for the 25% cold-worked material aged and tested at 593° C are also shown in Fig. 18. The growth rate for the cold-worked and aged specimen tested with no hold time is slightly higher than the growth rate of the cold-worked material tested at 593° C with no hold time. Impsoition of 0.1- and 1-min hold time in the cold-worked and aged specimens caused an increase in the growth rates over the most of the ΔK range relative to the zero-hold-time test. Changes in the slope occur in all three log da/dN vs log ΔK curves and at different values of ΔK . For comparable values of ΔK , the growth rates of the 25% cold-worked and aged specimens fall between the growth rate of the 25% cold-worked material with 1-min hold time and that of the 25% cold-worked specimen tested without hold time (Fig. 18).

Fig. 18 — Effect of hold time on fatigue propagation rates of solution-annealed Type 304 stainless steel, Heat A, 25% cold-worked, and 25% cold-worked and aged, tested at 593°C.

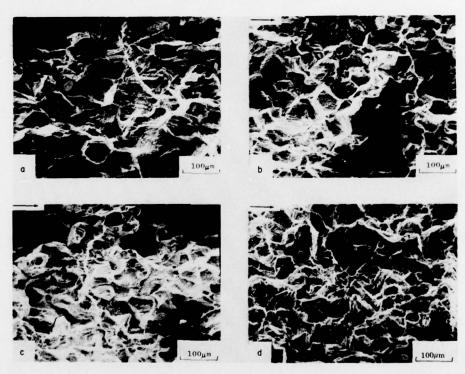
SEM examination of the fracture surface of the cold-worked specimen tested with 1-min hold time shows that the failure mode was largely intergranular, as illustrated in Fig. 19. The grain facets of this specimen were characterized by slip steps that are indicative of the local plastic deformation produced by the cold work. Unfortunately, the 25% cold-worked specimen tested without hold time could not be examined with the SEM because its fracture surface was severely damaged by oxidation.

Fig. 19 — Fracture surfaces of a Type 304 stainless steel specimen, Heat A, 25% coldworked and tested at 593°C with 1.0-min hold time. The SEM micrographs were taken at crack lengths that correspond to the following values of ΔK : (a) 22 MPa \sqrt{m} (20 ksi $\sqrt{\text{in.}}$), (b) 27.5 MPa \sqrt{m} (25 ksi $\sqrt{\text{in.}}$), (c) 33 MPa \sqrt{m} (30 ksi $\sqrt{\text{in.}}$), and (d) 44 MPa \sqrt{m} (40 ksi $\sqrt{\text{in.}}$). Arrows show direction of macroscopic crack propagation. The micrographs show that the failure mode is predominantly intergranular for all types of ΔK . The grain facets appear to be elongated and slip steps, indicative of local plastic deformation, are also present.

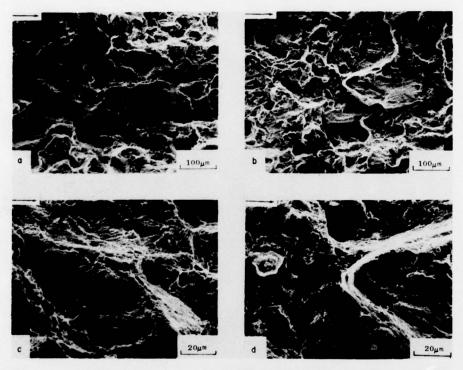
As illustrated by the SEM micrographs in Fig. 20, the fracture surface morphology of the 25% cold-worked and aged specimen tested at 593° C with 0.1-min hold time showed that the mode of failure was partly transgranular and partly intergranular for all values of ΔK . As was the case with the cold-worked specimen, some grain facets were characterized by slip steps running parallel to the macroscopic crack growth direction, thus indicating that a substantial amount of plastic deformation had occurred. An increase in the hold time from 0.1 to 1 min produced no significant change in the fractographic features, as illustrated in Fig. 21. The specimen tested without hold time could not be examined with the SEM because its fracture surface was severely damaged by oxidation, so no comparison with the zero-hold-time specimen was possible.

Fig. 20 — Fracture surfaces of a Type 304 stainless steel specimen, Heat A, 25% coldworked and aged, tested at 593°C with 0.1-min hold time. The SEM micrographs were taken at crack lengths that correspond to the following values of ΔK : (a) 27.5 MPa \sqrt{m} (25 ksi $\sqrt{\ln}$.), (b) 44 MPa \sqrt{m} (40 ksi $\sqrt{\ln}$.), (c) 27.5 MPa \sqrt{m} (25.ksi $\sqrt{\ln}$.), and (d) 44 MPa \sqrt{m} (40 ksi $\sqrt{\ln}$.). Arrows show direction of macroscopic crack propagation. The failure mode was mixed — transgranular and intergranular — in the entire crack path. Slip steps are also present in most grain facets.

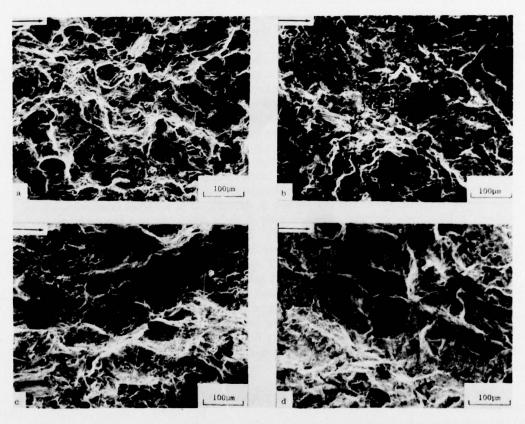
Fig. 21 — Fracture surfaces of a Type 304 stainless steel specimen, Heat A, 25% coldworked and aged, tested at 593°C with 1.0-min hold time. The SEM micrographs were taken at crack lengths that correspond to the following values of ΔK : (a) 22 MPa \sqrt{m} (20 ksi $\sqrt{\text{in.}}$), (b) 27.5 MPa \sqrt{m} (25 ksi $\sqrt{\text{in.}}$), (c) 33 MPa \sqrt{m} (30 ksi $\sqrt{\text{in.}}$), and (d) 44 MPa \sqrt{m} (40 ksi $\sqrt{\text{in.}}$). Arrows show direction of macroscopic crack propagation. The failure mode was mixed — intergranular and transgranular — in the entire crack path.
